HEMTT A4 and  
PLS A1 Trucks...

## STEERING COLUMN WIRING HARNESS CHANGED!

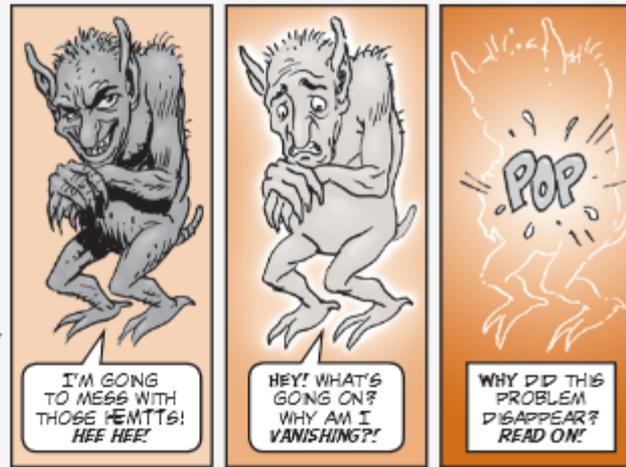
A production issue caused a cab wiring harness to rub against a grease fitting on the steering column of these HEMTT A4 and PLS A1 trucks. That contact can lead to a damaged wiring harness, including sparking of exposed wires or shearing of the wires. But the good news is, steering and other safety-related functions aren't affected.

More good news is that Oshkosh Corporation will inspect and modify suspect trucks. In fact, Oshkosh will provide the required parts and labor to correct this problem at no cost to units. The repair work will include removing and disposing of the problem grease fitting, installing a plug to fill the opening, and adding two half-inch wide cable ties.
