Making Room for BAP Winch Frame Repair

The winch frame locking tabs on the bridge adapter pallet (BAP) have been known to break off during common bridge transporter operations.

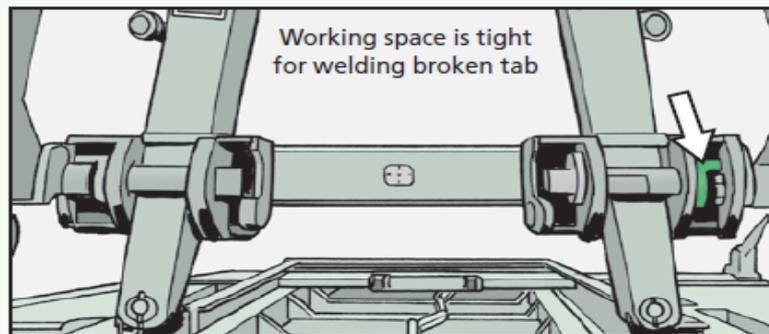
Problem is, welding a busted tab back into place is a bit tricky. There's just not a lot of elbow room in that confined space. But the locking tabs are critical items when loading and unloading the improved ribbon bridge from the common bridge transporter.

There's a new 21-step field maintenance repair procedure that should be used to fix a broken tab instead of WP 0054 in TM 5-330-263-13&P. To get an electronic copy of the fix, email Half-Mast at: half.mast@us.army.mil
