FMTV...

# LTAS HYDRAULIC BRAKE CONVERTER CONFLICT

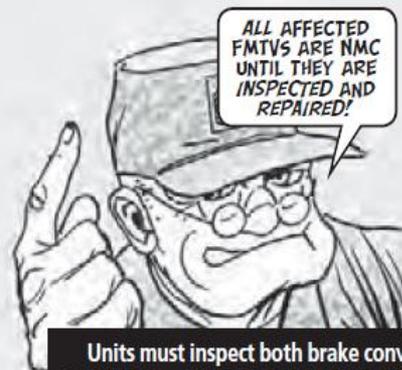
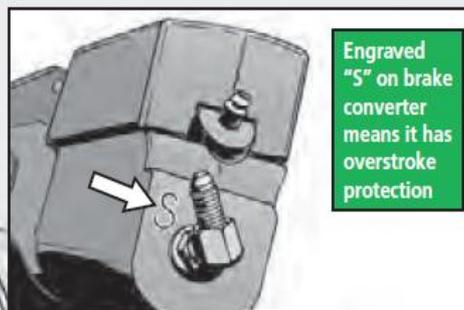
**L**isten up, FMTV users! IETM versions dated earlier than Sep 2010, new equipment training and TACOM SOUM 11-005 incorrectly tell maintainers to pump the brake pedal to bleed air from the brake hydraulic system. That mistake has resulted in damaged brake converters due to overstroke on LTAS FMTV trucks with a serial number before 707,449.

Overstroke occurs when the brake pedal is pumped when there is air or a leak in the hydraulic brake system. The resulting damage to the brake converter causes poor brake performance or sharp pulling of the FMTV left or right during heavy braking.

Units must inspect both brake converters on LTAS trucks with serial numbers lower than 707,449. See TACOM SOUM 11-013 for inspection and repair details. The instructions are pretty long, but there are detailed pictures to help you out. You can get to the guidance you need online: [https://tulsa.tacom.army.mil/safety/soum/tacom\\_wn/sou11-013.html](https://tulsa.tacom.army.mil/safety/soum/tacom_wn/sou11-013.html)
