# VEHICLE PASSENGER LIMITS

# LTAS HYDRAULIC BRAKE CONVERTER CONFLICT

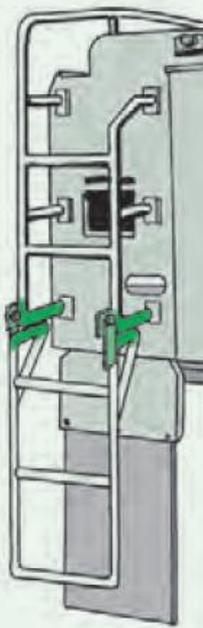
Well, turns out that ladders need PMCS, too. Injuries have been caused by damaged HEMTT ladders—some serious enough that workers have lost fingers.

Even on a ladder that is not damaged, the hinge between the bottom and top halves of the ladder is a pinch point. Follow the warnings in the TM and keep hands clear of the ladder hinge.

Ladder hinge is a pinch point. Keep hands clear

When doing weekly PMCS on your HEMTT, don't forget to check that the safety pins are in place to secure the ladder properly. Repair or replace any damaged components you find. If necessary, replace the whole ladder.

A ladder can get damaged when it's accidentally left in the down position. Remember to stow your HEMTT's ladder when it's not in use or before you move the truck. Follow the guidance in your specific HEMTT model's operator's manual.

Use these NSNs to order new retention pin hardware for ladders

Item	NSN
Wire rope	4010-01-162-9825
Clevis pin	5315-01-197-0608
Ladder clip	5340-01-155-3590
