M777A2  
Towed  
Howitzer...

# KEEP TOWING LUNETTE TIGHT

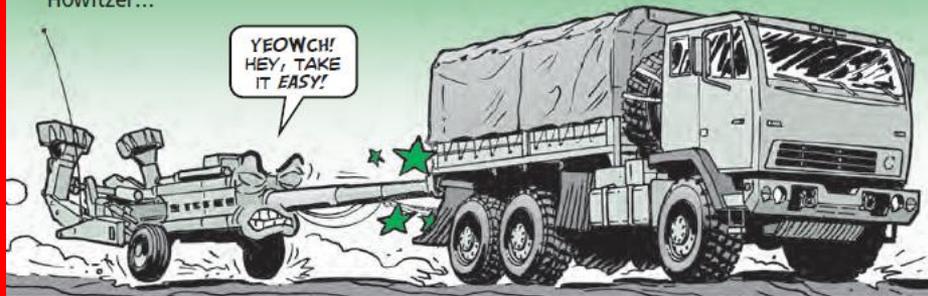
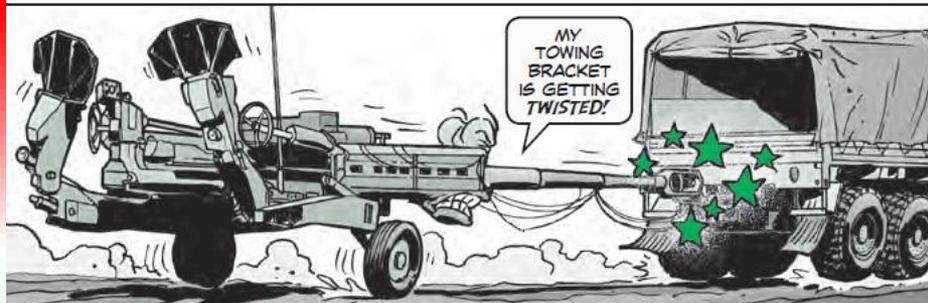
If the lunette isn't tightened down properly, it allows a twisting motion during towing. It doesn't take too much twisting to damage the muzzle brake's tow bracket. The fix requires a depot-level welding and re-machining of the bracket.

You can prevent that expensive damage by making sure both the washer, NSN 5365-01-528-9349, and long nut, NSN 5310-01-528-9347, are in place. Then keep the long nut torqued to 350 lb-ft.
