HAPPY NEW YEAR FROM THE
TRANSPORTATION CORPS:

A/C V-Belt Pulley Interference

REPLACE SPARE TIRE CARRIER CHAIN STUDS!

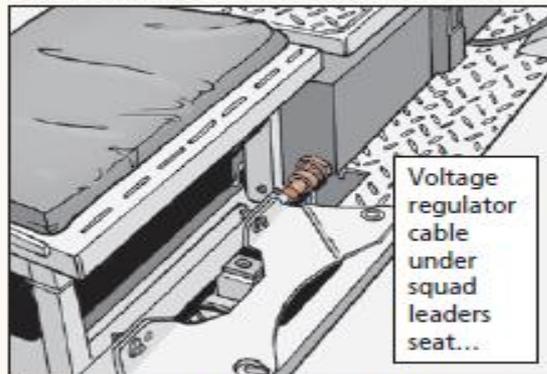
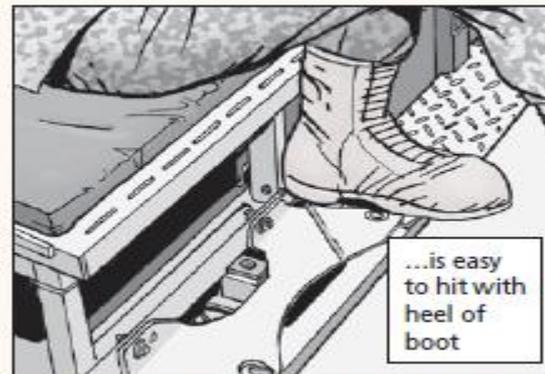
The W4 cable that screws into the side of the battery box sits right under the squad leader's seat. It would be really easy for a Soldier's heel to hit the W4 cable and either damage it or slowly unscrew it.

A damaged or loosened cable won't allow the vehicle's batteries to charge. You can spend a lot of time and lose a lot of sleep trying to troubleshoot this problem. So make it one of your first checks.

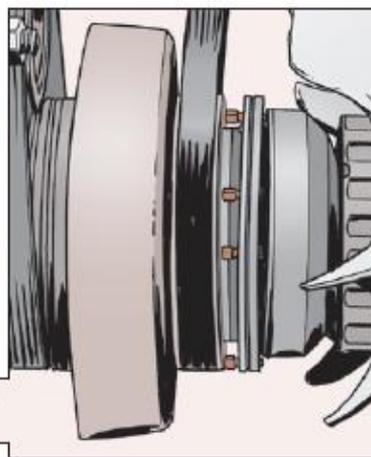
If your unit has FMTVP1, FMTVA1P1, FMTVA1P2, LVAD and HIMARS trucks with air conditioning, you may have a problem. There could be contact between the engine fan clutch bolts and the A/C V-belt pulley. The contact itself doesn't make your truck non-mission capable, though.

But the bad news is, depending on how much contact there is between the pulley and fan clutch, the fan clutch could fail or the fan clutch assembly could be damaged. And that does make your truck NMC.

Fan clutch retaining bolts with small clearance to A/C pulley can cause damage

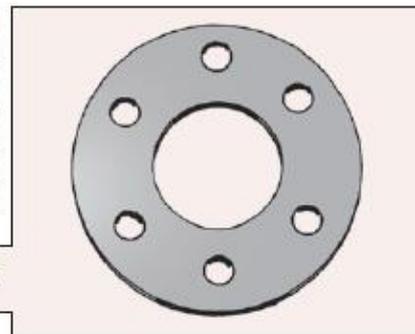
Fan clutch spacer plate, P/N GTS006001, provides extra clearance

The good news is a spacer plate is available through BAE Systems to fix this issue. The spacer plate provides more clearance between the fan clutch and A/C V-belt pulley. Use it if the fan clutch retaining ring bolts are worn and need to be replaced or if the fan clutch itself is damaged.

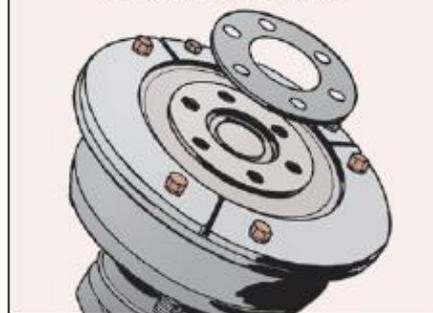
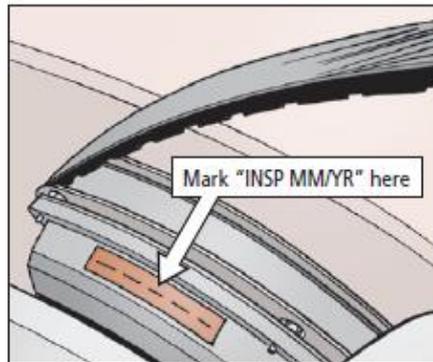
Fan clutch retaining ring bolts may become loose due to contact and heat friction with A/C pulley

1. Look for metal-to-metal contact from the fan clutch bolt heads to the face of the A/C pulley.
2. If you see any damage to the fan clutch, replace it and install the new spacer, PN GTS006001, on the new fan clutch. Refer to the TACOM MAM for details on how to get the spacer.

3. If the fan clutch retaining ring bolts are excessively worn and can't be tightened, replace the fan clutch and install the new spacer plate.
4. Undamaged or slightly worn retaining ring bolts with no other signs of damage to the fan clutch or A/C pulley can be tightened. Torque loose retaining ring bolts to 30 lb-in.

5. If you can't use this torque wrench method, use this alternate tightening method: Once the bolt is seated and the lock washer is compressed with no gap between the retaining plate and clutch, tighten the bolt with an additional $\frac{1}{4}$ to $\frac{3}{8}$ turn.

6. After inspecting and following these steps, use a paint pen to mark serviceable fan clutches: "Insp. Month/Year", for example, Insp. 12/12.

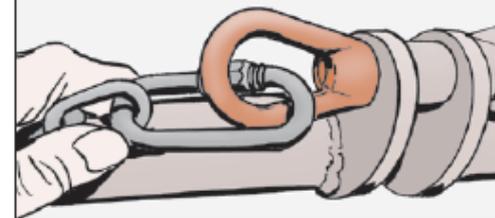
If your unit has FMTV A1P2 trucks with serial numbers below 737,560, or LVAD model M1081A1 and M1093 trucks within serial number range L-T120386EHFV to M-T120972EHBW, your truck's spare tire lifting eye studs could fail. And that can lead to the entire 363-lb wheel and tire assembly falling, injuring personnel and damaging equipment.

Thankfully, this preventable problem doesn't make your truck NMC. The trouble was created during vehicle production when the spare tire lifting eye nuts on these trucks were over-tightened. The resulting slightly stretched studs in turn weakened the stud threads.

Lifting eye assembly secures spare tire chain

Prevent a possible failure by replacing the eye nut studs, NSN 5307-01-416-9968. Install them with the proper torque value of 44 ft-lbs.

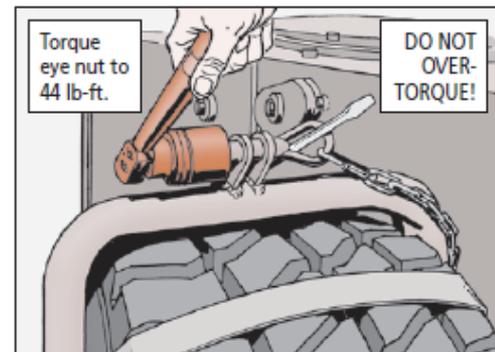
Torque eye nut to 44 lb-ft.

DO NOT OVERTORQUE!

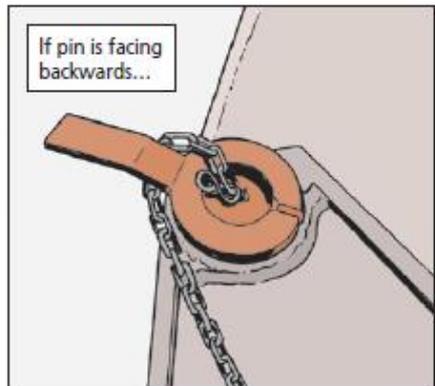
If pin is facing backwards...

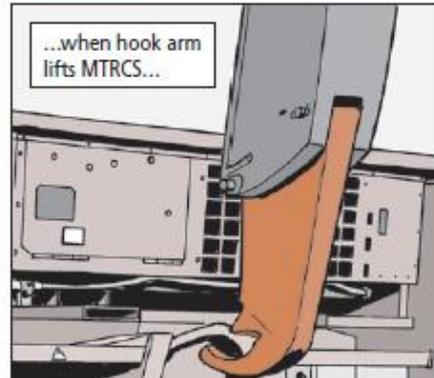
...when hook arm lifts MTRCS...

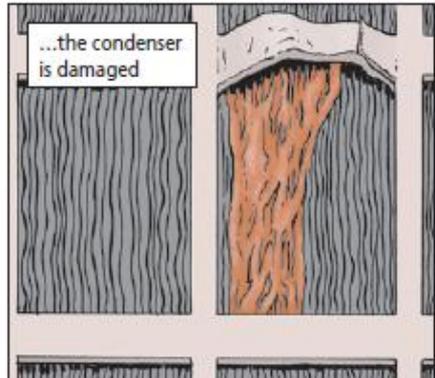
OPERATORS, THE REFRIGERATION CONDENSER UNITS IN THE MULTI-TEMPERATURE REFRIGERATED CONTAINER SYSTEM (MTRCS) ARE SUFFERING A LOT OF DAMAGE.

THAT'S BECAUSE THE HOOK ARM PIN ON THE M1074/A1 PLS AND M1120/A2/A4 HEMTT LHS CAN MOVE FREELY IN THE ARM.

...the condenser is damaged

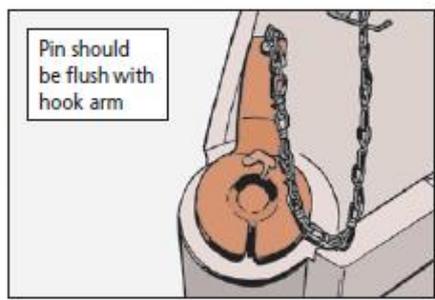
Pin should be flush with hook arm

THE PIN SHOULD BE FLUSH WITH THE HOOK ARM, NOT PROTRUDING FROM THE HOOK ARM'S FRAME.

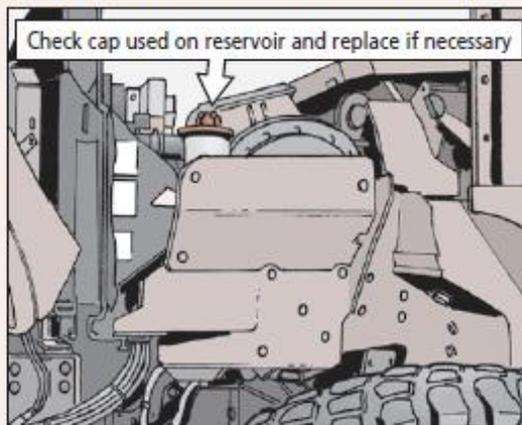
The culprit is usually the vehicle's original power steering reservoir cap, NSN 2590-01-556-5316. It's a known leaker.

To stop fluid loss, replace the old cap with a new style cap. The new cap, NSN 6680-20-006-4251, has three baffles on its dipstick that keep fluid from seeping past the cap.

So eyeball the cap you have on your MaxxPro. If it's the old-style cap, replace it now.
