# QUICK CHECK FOR THE QUICK-DISCONNECT

There's been a rash of blown steering gear seals on the M1117 armored security vehicle (ASV) and M1200 Armored Knight fire support vehicle (FSV) lately.

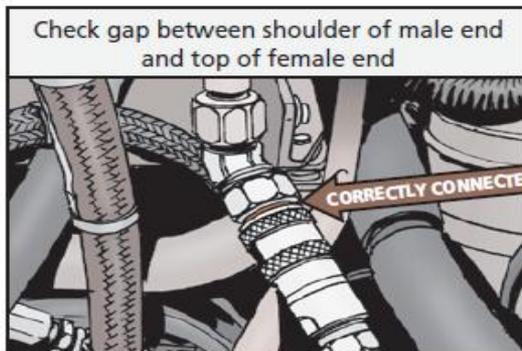
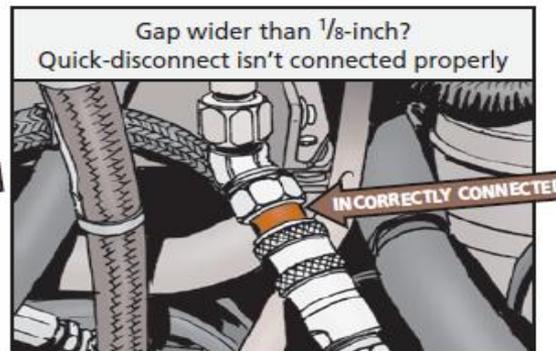
Some mechanics haven't been careful enough when connecting the hydraulic system's supply and return lines. If the quick-disconnect isn't fully seated, the hydraulic system will over-pressurize, causing a blown seal on the steering gearbox. A blown seal makes the vehicle NMC!

When connecting the supply and return line quick-disconnects, make sure there's no more than a  $\frac{1}{8}$ -in gap between the shoulder of the male end and the top of the female end. A wider gap means the hose line isn't properly connected.

This problem is happening more and more often after annual services. So before you finish with services, eyeball the hydraulic line connection for the correct gap.
