COVER STOPS CABLE FAILURE

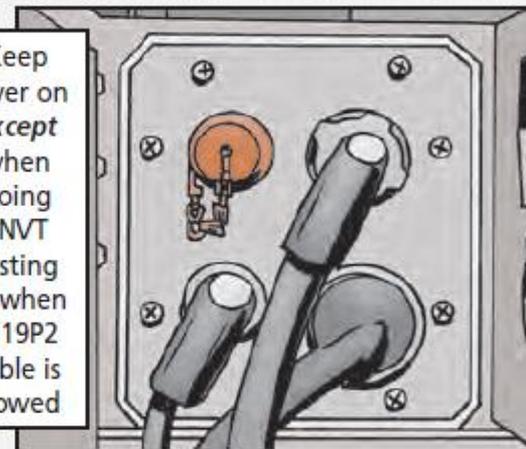
Without the cover, the connector has no protection against moisture or backblast from rockets firing. Corrosion eats away at the connector's pins and soon there's no electrical connection.

Keep cover on **except** when doing SNVT testing or when W19P2 cable is stowed

So do your HIMARS a favor and use the W529 cover. And check for the cover during your weekly PMCS. Order a new one through your Lockheed Martin rep with P/N MS27502B17N if it's missing.
