Tactical
Vehicles...

Loose Torque Rod Locknuts Cause Deadlines

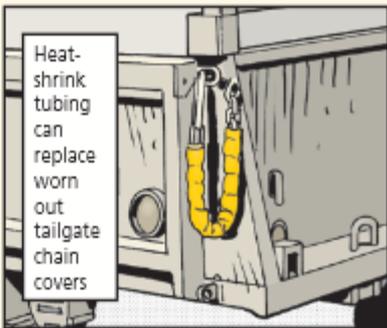
I've noticed many tailgate chains on tactical vehicles are being replaced due to a missing or torn chain cover. The rubber cover gets exposed to all types of weather and deteriorates over time.

Heat-shrink tubing can replace worn out tailgate chain covers

Since the chain covers are basically for noise discipline, the DOL while I was at Fort Hood started using heat-shrink tubing on the chains instead of replacing the entire chain assembly. NSN 5970-00-815-1300 gets you the 1-in heat-shrink tubing. It shrinks to $\frac{1}{2}$ inch and costs only **43 cents** per foot. Plus, it takes just two minutes to install.

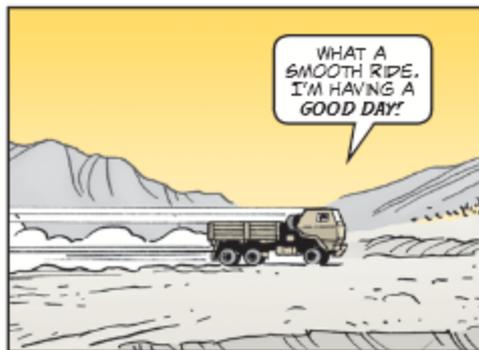
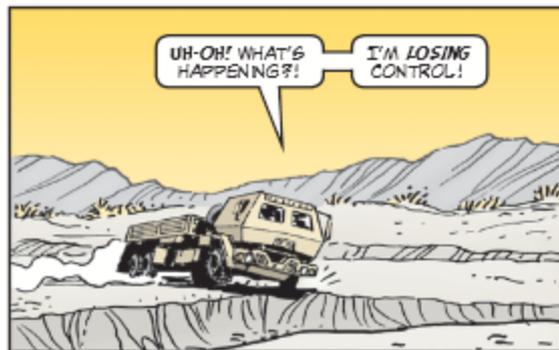
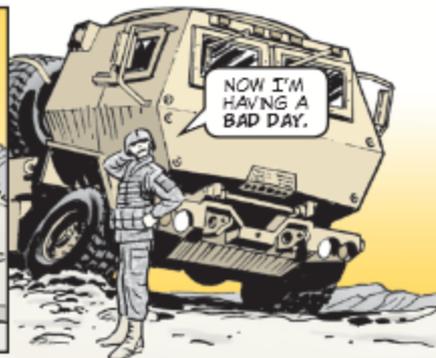
If you haven't already heard, a production error caused some FMTVA1P2 LTAS 6X6 (3-axle variant) trucks within the serial number range of 720,001-744,192 and M1095 trailers within the serial number range of 720,038-759,324 to roll off the line with improperly tightened torque rod nylon insert locknuts, NSN 5310-01-434-0078. The vehicles have four individual torque rods secured by eight nylon insert locknuts. If these locknuts are not installed and torqued properly, the individual torque rod could separate from the truck or trailer, putting you at risk for a loss of control, rollover, and collision.

By now, the corrective measures provided in TACOM SOUM 12-015 and TACOM SOUM 13-005 should be completed. But if they haven't been, or if you encounter loose torque rod locknuts, here's what you should do.

For your FMTVA1P2 LTAS truck, use the maintenance instructions found in the Rear Torque Rod Replacement work package of TM 9-2320-333-14&P (EM 0294, Jun 12). And for your M1095 trailer, refer to the maintenance guidance in WP 0097 of TM 9-2330-394-13&P.

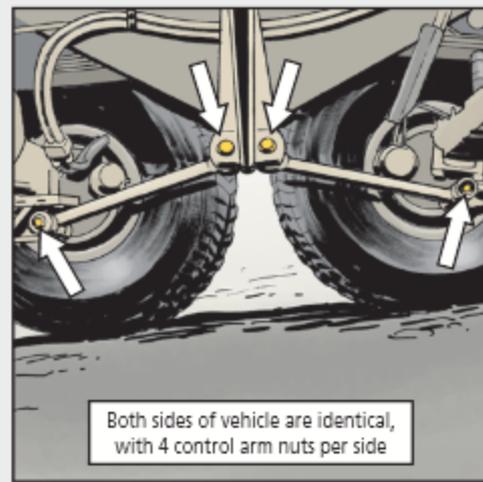
Check for Extending Threads

Immediately inspect your FMTV LTAS 6X6 truck and M1095 trailer to see if each torque rod nylon insert locknut has threads that are visible beyond the locknut. A properly tightened nylon insert locknut will show 1-3 threads exposed past the nylon lock feature.

You won't see extending threads if the locknut is improperly torqued. That means your truck or trailer is non-mission capable (NMC) until all the nylon insert locknuts have been properly torqued.

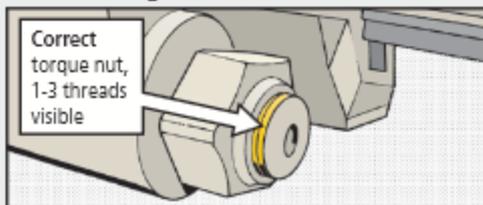
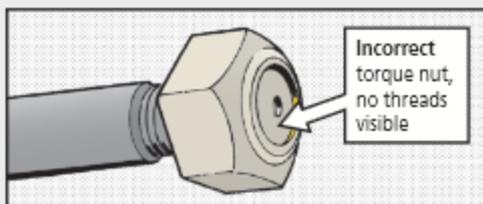
Color Coding

See any green or blue markings on the locknuts? Then your truck or trailer is good. But if you don't see these marks, a green mark is needed after your vehicle gets a passing inspection, or when corrective actions have been completed. Mark each torque rod nylon insert locknut with a small green marking.

If blue torque seal markings have been applied to all eight locknuts, Oshkosh has already inspected the vehicle. If your truck or trailer serial number is within the ranges we gave you earlier, and your unit hasn't given a status report, make sure you follow the guidance in TACOM SOUM 12-015 and TACOM SOUM 13-005.

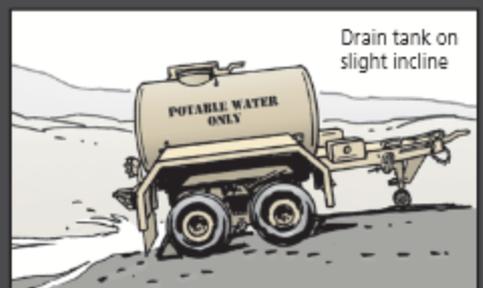
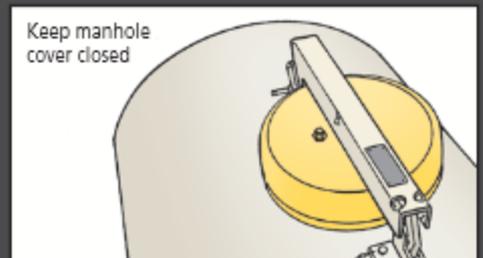
Rusty Stainless Steel

If the water from a stainless steel tank has a rusty, metallic taste, check the welded joints in the tank for rust.

Scrub away rust with a solution of water and scouring powder, NSN 7930-01-294-1116. Always use a nonmetallic, nylon brush. You can get one with NSN 7920-00-061-0038.

Flush the tank thoroughly with clean water. Scrub it again if you still see rust. You're done when the rust is gone.
