**M**echanics, seems like just about any place a Soldier puts his big feet can cause you problems. The latest spot is inside the troop compartment of the Stryker.

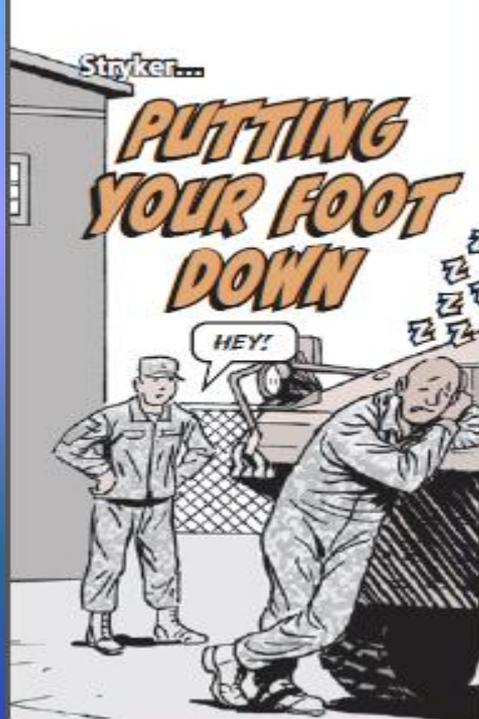
The W4 cable that screws into the side of the battery box sits right under the squad leader's seat. It would be really easy for a Soldier's heel to hit the W4 cable and either damage it or slowly unscrew it.

Voltage regulator cable under squad leaders seat...

A damaged or loosened cable won't allow the vehicle's batteries to charge. You can spend a lot of time and lose a lot of sleep trying to troubleshoot this problem. So make it one of your first checks.

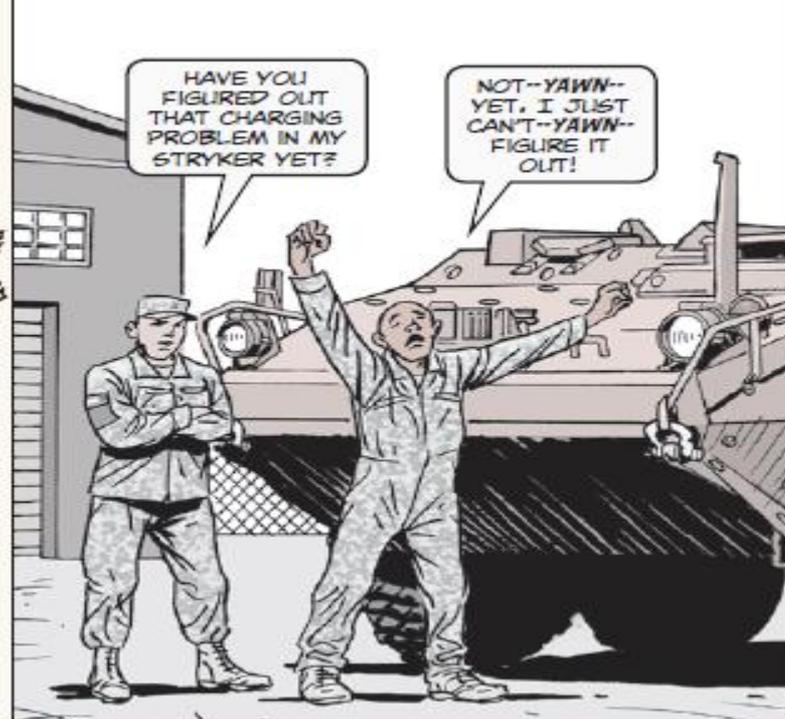
...is easy to hit with heel of boot
