# CUT THE HOSE RUB

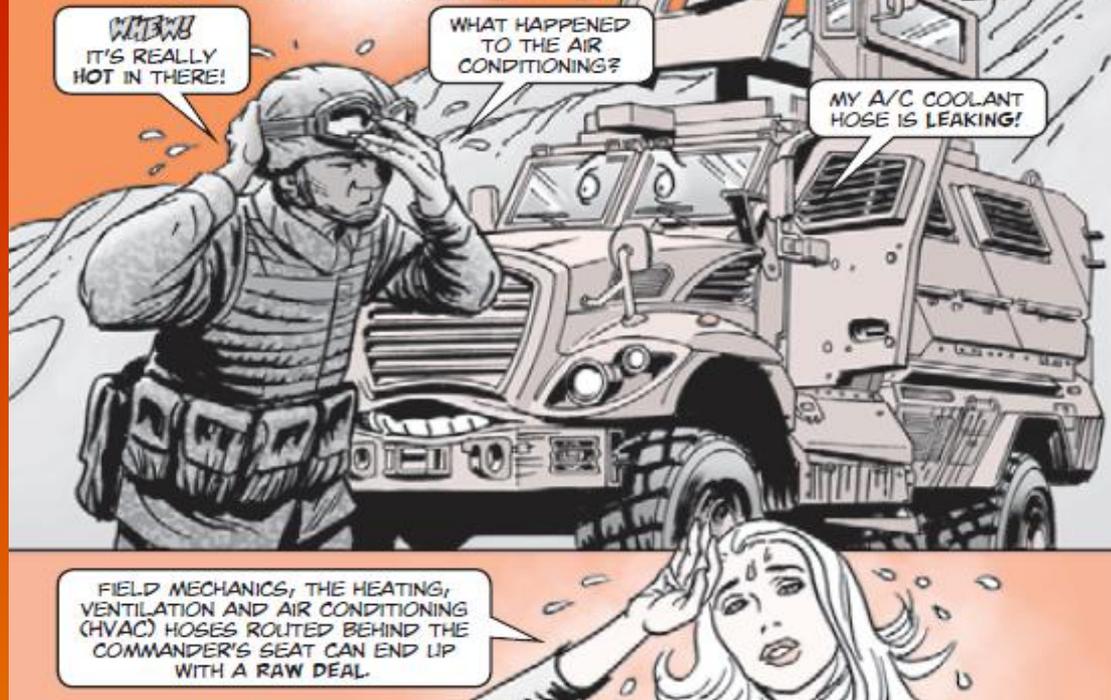
Get real close and eyeball the hoses for any wear marks. These hoses rub against the seat. Too much wear means a hole with coolant leaking out. Without coolant, there's no air conditioning. Talk about hot tempers in Southwest Asia!

See any rubs? Use a 6-in tie-down strap, NSN 5975-00-984-6582, to hold the HVAC hoses in place away from the seat. Place the strap on the hoses about six inches away from the I-bolt that's mounted on the back of the seat.
