PM That Works

COMBAT ENGINEERS NEED TO KEEP THESE PREVENTIVE MAINTENANCE TIPS IN MIND TO KEEP THE HUSKY MISSION-READY.

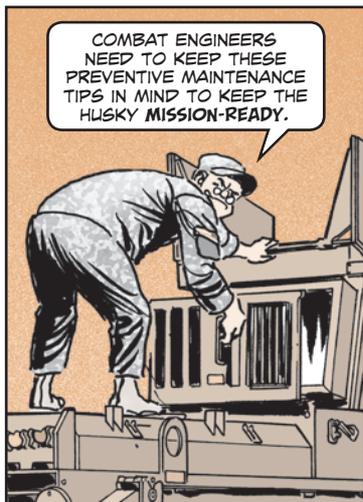
THE MK III HUSKY THAT DETECTS BURIED IEDS DURING ROUTE CLEARANCE OPERATIONS IS A REAL LIFE SAVER.

HEY, GUYS! I FOUND AN IED HERE!

WAY TO GO, GROUND PENETRATING RADAR!

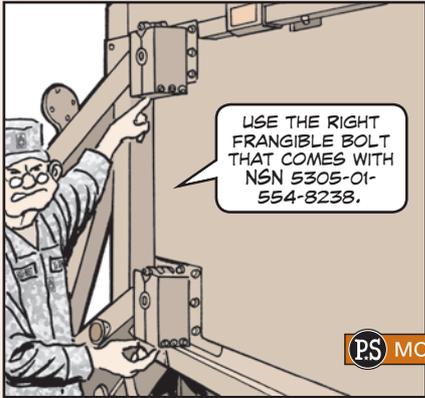
Some frangible bolts in the vehicle's front and rear wheel modules are designed to break during IED or land mine explosions.

Some well-meaning, but misguided, mechanics are replacing the bolts with stronger Grade 8 bolts that reduce Soldier protection. Plain and simple, these frangible bolts were designed for crewmember survivability, not maintenance efficiency.

USE THE RIGHT FRANGIBLE BOLT THAT COMES WITH NSN 5305-01-554-8238.

The correct bolt comes with NSN 5305-01-554-8238. Use it! Also, use the nylon-locknut, NSN 5310-01-554-4749, that holds each bolt in place.

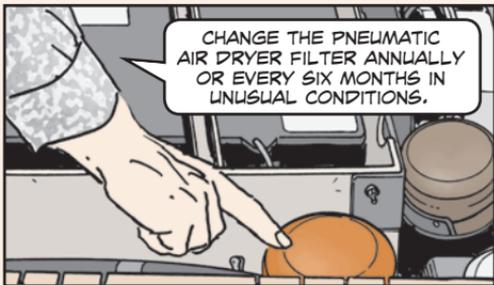
Air Dryer Filter Update

You'll end up scratching your head trying to find the service interval for the vehicle's air dryer filter. Stop looking! It's missing from the technical manual and lubrication order. So, play it safe and change the filter annually or every six months for unusual conditions.

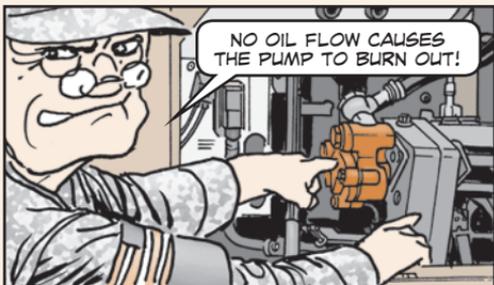
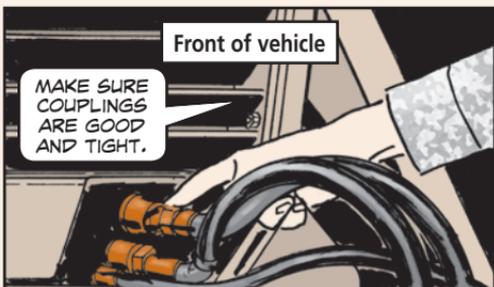
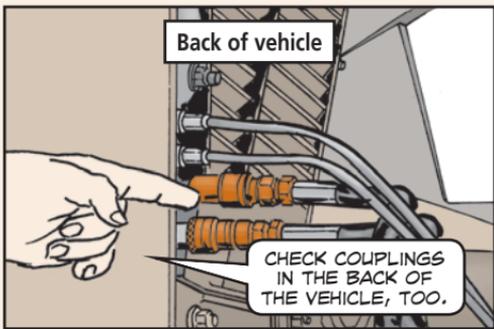
Use a little TLC when you remove the front or rear access door to the transmission. It's real easy to bump a door into a quick-disconnect coupling that attaches hydraulic oil lines to the vehicle's power steering.

When that happens, a loose connection causes hydraulic oil in the power steering pump to back up. When oil can't flow and has no place to go, guess what? All that pressure causes the pump to crack and leak. Enough of a leak means no oil, causing the pump to burn out. Then you're stuck with a "dead head" pump and a Husky without power steering!

Also, when the couplings are removed during maintenance, make sure the locking bearings in the female coupling slide back-and-forth freely. Stuck couplings may be clogged with dirt and sand.

Do yourself a favor and make sure the couplings are good and tight when you remove or reinstall an access door.

Damaged couplings? Replace the female coupling with NSN 4730-01-554-8869 and male coupling with NSN 4730-01-555-5385.
