FMTV...

# LTAS HYDRAULIC BRAKE CONVERTER CONFLICT

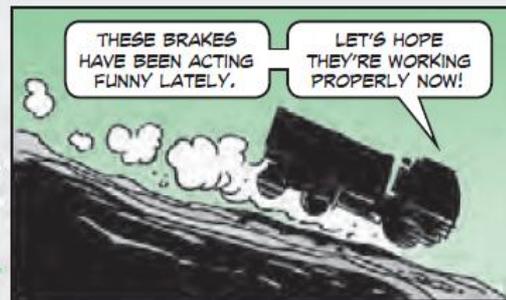
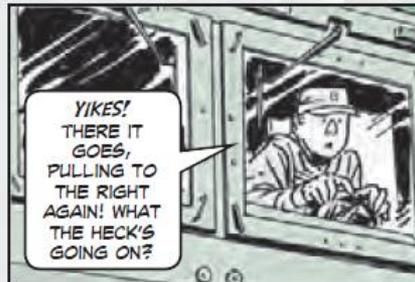
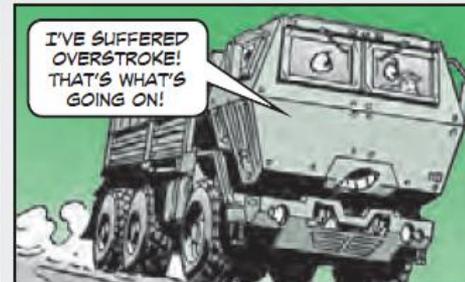
**L**isten up, FMTV users! IETM versions dated earlier than Sep 2010, new equipment training and TACOM SOUM 11-005 incorrectly tell maintainers to pump the brake pedal to bleed air from the brake hydraulic system. That mistake has resulted in damaged brake converters due to overstroke on LTAS FMTV trucks with a serial number before 707,449.

Overstroke occurs when the brake pedal is pumped when there is air or a leak in the hydraulic brake system. The resulting damage to the brake converter causes poor brake performance or sharp pulling of the FMTV left or right during heavy braking.

Units must inspect both brake converters on LTAS trucks with serial numbers lower than 707,449. See TACOM SOUM 11-013 for inspection and repair details. The instructions are pretty long, but there are detailed pictures to help you out. You can get to the guidance you need online: [https://tulsa.tacom.army.mil/safety/soum/tacom\\_wn/sou11-013.html](https://tulsa.tacom.army.mil/safety/soum/tacom_wn/sou11-013.html)
