# VEHICLE PASSENGER LIMITS

# LTAS HYDRAULIC BRAKE CONVERTER CONFLICT

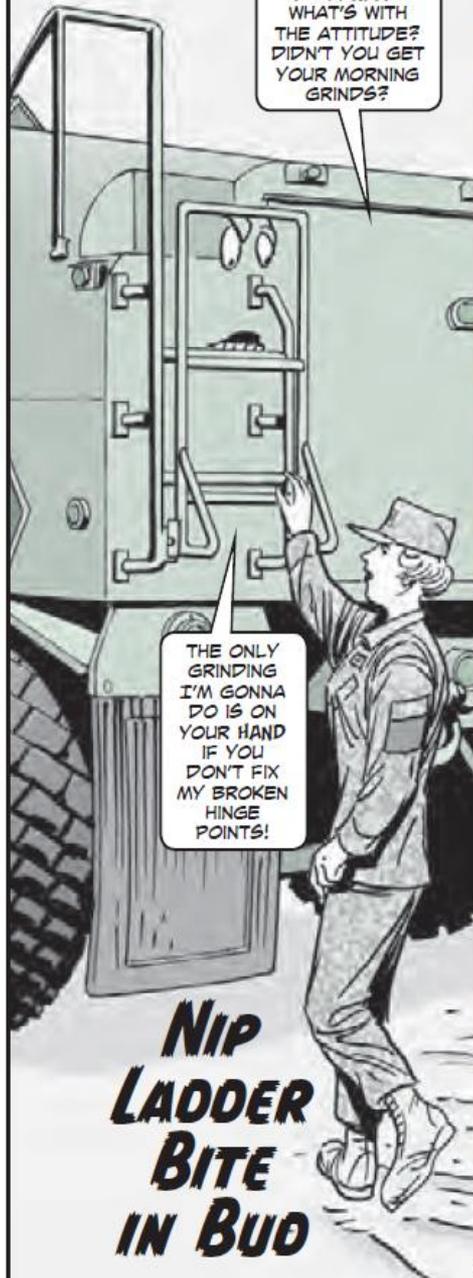
THE ONLY GRINDING I'M GONNA DO IS ON YOUR HAND IF YOU DON'T FIX MY BROKEN HINGE POINTS!

Well, turns out that ladders need PMCS, too. Injuries have been caused by damaged HEMTT ladders—some serious enough that workers have lost fingers.

Even on a ladder that is not damaged, the hinge between the bottom and top halves of the ladder is a pinch point. Follow the warnings in the TM and keep hands clear of the ladder hinge.

When doing weekly PMCS on your HEMTT, don't forget to check that the safety pins are in place to secure the ladder properly. Repair or replace any damaged components you find. If necessary, replace the whole ladder.

A ladder can get damaged when it's accidentally left in the down position. Remember to stow your HEMTT's ladder when it's not in use or before you move the truck. Follow the guidance in your specific HEMTT model's operator's manual.

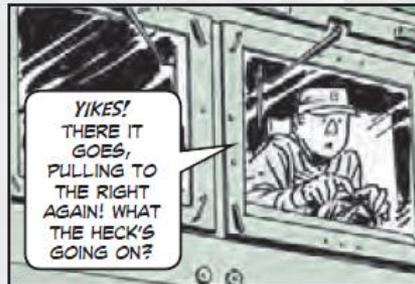
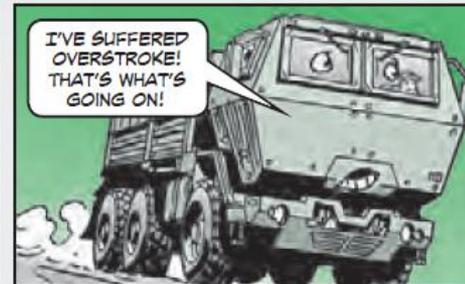
**L**isten up, FMTV users! IETM versions dated earlier than Sep 2010, new equipment training and TACOM SOUM 11-005 incorrectly tell maintainers to pump the brake pedal to bleed air from the brake hydraulic system. That mistake has resulted in damaged brake converters due to overstroke on LTAS FMTV trucks with a serial number before 707,449.

Overstroke occurs when the brake pedal is pumped when there is air or a leak in the hydraulic brake system. The resulting damage to the brake converter causes poor brake performance or sharp pulling of the FMTV left or right during heavy braking.

Units must inspect both brake converters on LTAS trucks with serial numbers lower than 707,449. See TACOM SOUM 11-013 for inspection and repair details. The instructions are pretty long, but there are detailed pictures to help you out. You can get to the guidance you need online: [https://tulsa.tacom.army.mil/safety/soum/tacom\\_wn/sou11-013.html](https://tulsa.tacom.army.mil/safety/soum/tacom_wn/sou11-013.html)
