HAPPY NEW YEAR FROM THE
TRANSPORTATION CORPS:

A/C V-Belt Pulley Interference

REPLACE SPARE TIRE CARRIER CHAIN STUDS!

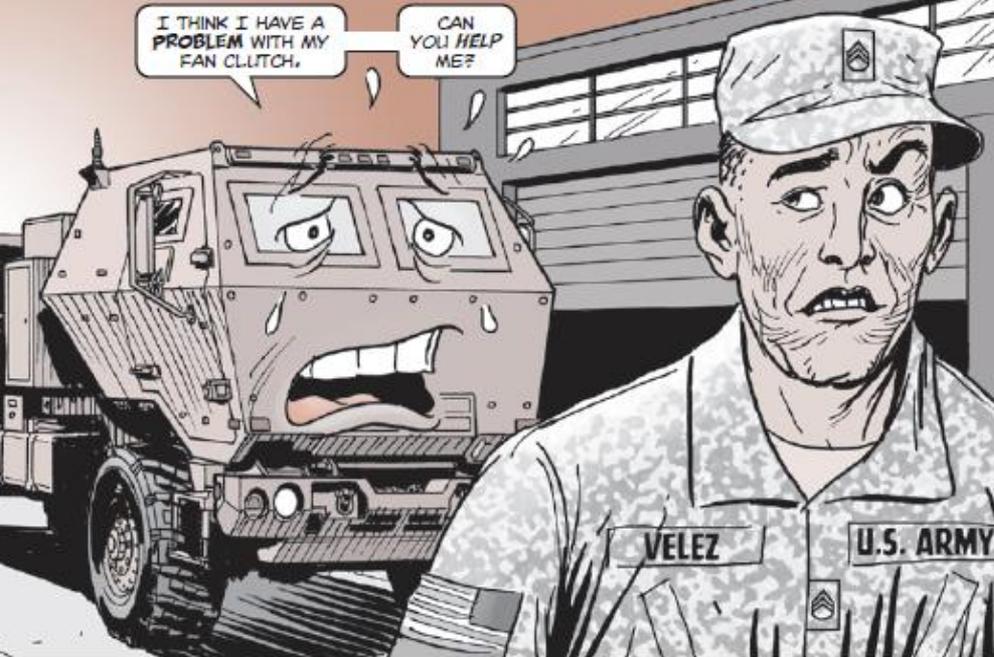
If your unit has FMTVP1, FMTVA1P1, FMTVA1P2, LVAD and HIMARS trucks with air conditioning, you may have a problem. There could be contact between the engine fan clutch bolts and the A/C V-belt pulley. The contact itself doesn't make your truck non-mission capable, though.

But the bad news is, depending on how much contact there is between the pulley and fan clutch, the fan clutch could fail or the fan clutch assembly could be damaged. And that does make your truck NMC.

Fan clutch retaining bolts with small clearance to A/C pulley can cause damage

The good news is a spacer plate is available through BAE Systems to fix this issue. The spacer plate provides more clearance between the fan clutch and A/C V-belt pulley. Use it if the fan clutch retaining ring bolts are worn and need to be replaced or if the fan clutch itself is damaged.

1. Look for metal-to-metal contact from the fan clutch bolt heads to the face of the A/C pulley.
2. If you see any damage to the fan clutch, replace it and install the new spacer, PN GTS006001, on the new fan clutch. Refer to the TACOM MAM for details on how to get the spacer.

3. If the fan clutch retaining ring bolts are excessively worn and can't be tightened, replace the fan clutch and install the new spacer plate.
4. Undamaged or slightly worn retaining ring bolts with no other signs of damage to the fan clutch or A/C pulley can be tightened. Torque loose retaining ring bolts to 30 lb-in.

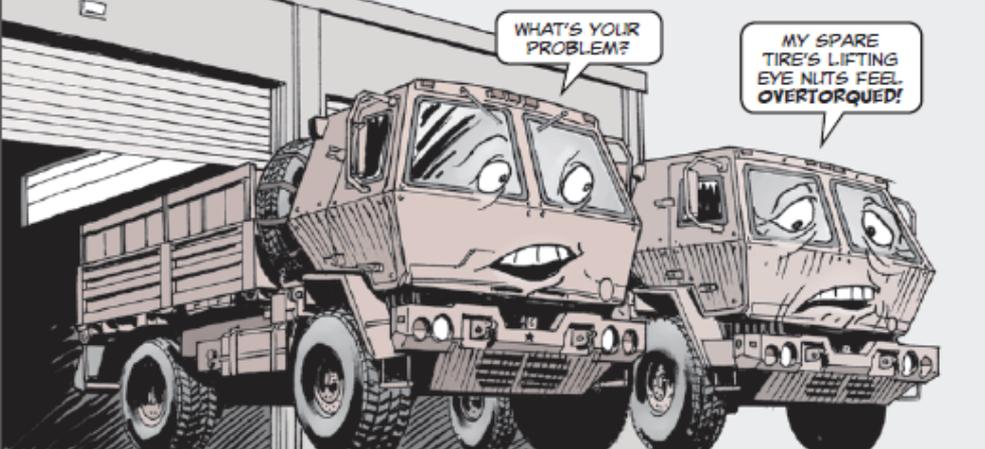
If your unit has FMTV A1P2 trucks with serial numbers below 737,560, or LVAD model M1081A1 and M1093 trucks within serial number range L-T120386EHFV to M-T120972EHBW, your truck's spare tire lifting eye studs could fail. And that can lead to the entire 363-lb wheel and tire assembly falling, injuring personnel and damaging equipment.

Thankfully, this preventable problem doesn't make your truck NMC. The trouble was created during vehicle production when the spare tire lifting eye nuts on these trucks were over-tightened. The resulting slightly stretched studs in turn weakened the stud threads.

Prevent a possible failure by replacing the eye nut studs, NSN 5307-01-416-9968. Install them with the proper torque value of 44 ft-lbs.

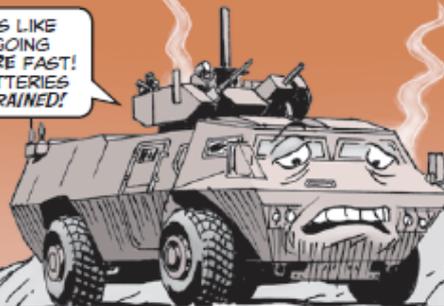
CIRCUIT BREAKER REMINDER

If the breakers are left ON—especially the one for the transmission—the vehicle batteries will drain in no time.

Crewmen, make sure the circuit breakers in your M1117 armored security vehicle (ASV) are switched OFF after the day's run.

So, switch off the breakers right before you turn off the engine. That way you're not stuck with dead batteries the next morning when it's time to start up the vehicle!

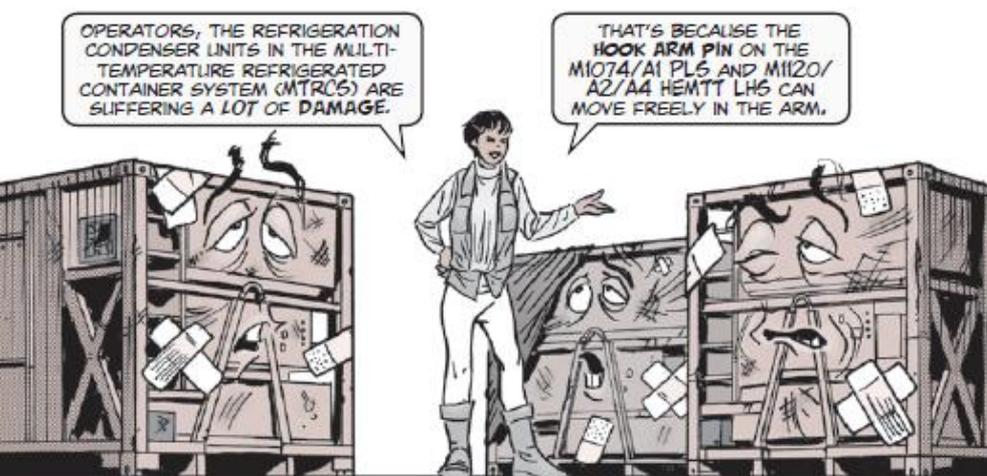
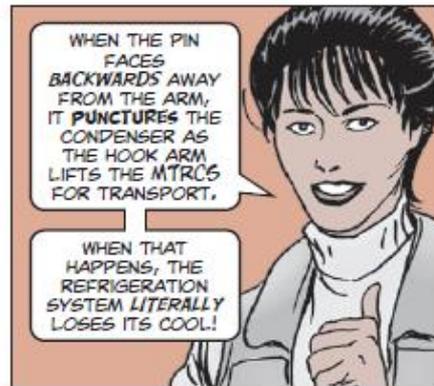
TURN HOOK ARM PIN AROUND

OPERATORS, THE REFRIGERATION CONDENSER UNITS IN THE MULTI-TEMPERATURE REFRIGERATED CONTAINER SYSTEM (MTRCS) ARE SUFFERING A LOT OF DAMAGE.

THAT'S BECAUSE THE HOOK ARM PIN ON THE M1074/A1 PLS AND M1120/A2/A4 HEMTT LHS CAN MOVE FREELY IN THE ARM.

WHEN THAT HAPPENS, THE REFRIGERATION SYSTEM LITERALLY LOSES ITS COOL!

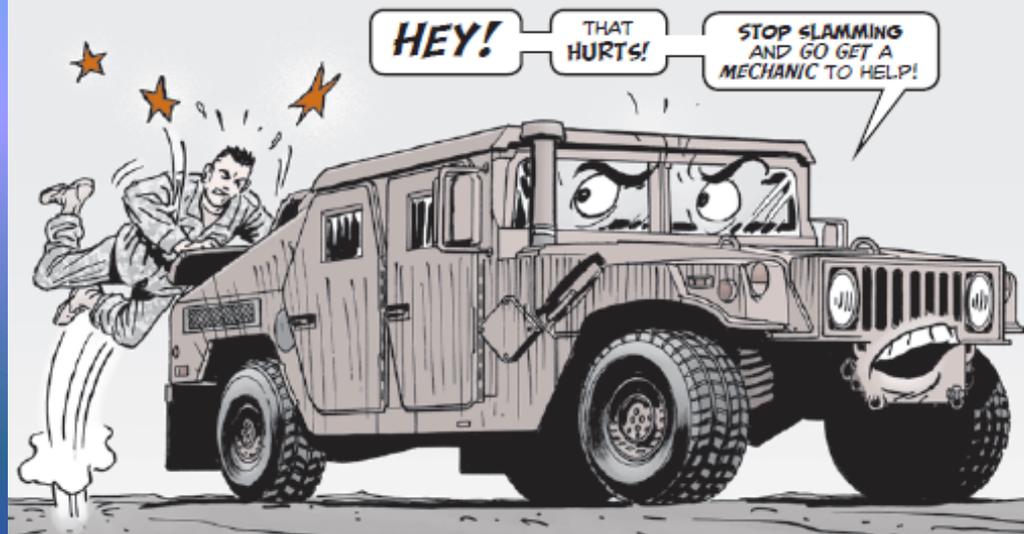
FIX CARGO SHELL LATCH PLATE FAILURE

If your M1151, M1151A1, M1151A1WB1, and M1167 HMMWVs have failing cargo shell forward latch plate assemblies, you might be a little frustrated. Here's what you can do to prevent the failures and ease the frustration.

But if you do all that and there's still a problem, your HMMWV's cargo shell forward latch plate assembly may have failed.

If your HMMWV's hatch doesn't close smoothly during PMCS, tell your mechanic. And make sure you're opening and closing it the right way.

Also, ensure the forward latches are fully engaged with the forward strikers before opening the cargo door from the rear position. That should help protect the cargo shell forward latch plate assembly.

You can't find replacement procedures in the TM yet, but you can get them from TACOM LCMC. Just send your unit information and request to:

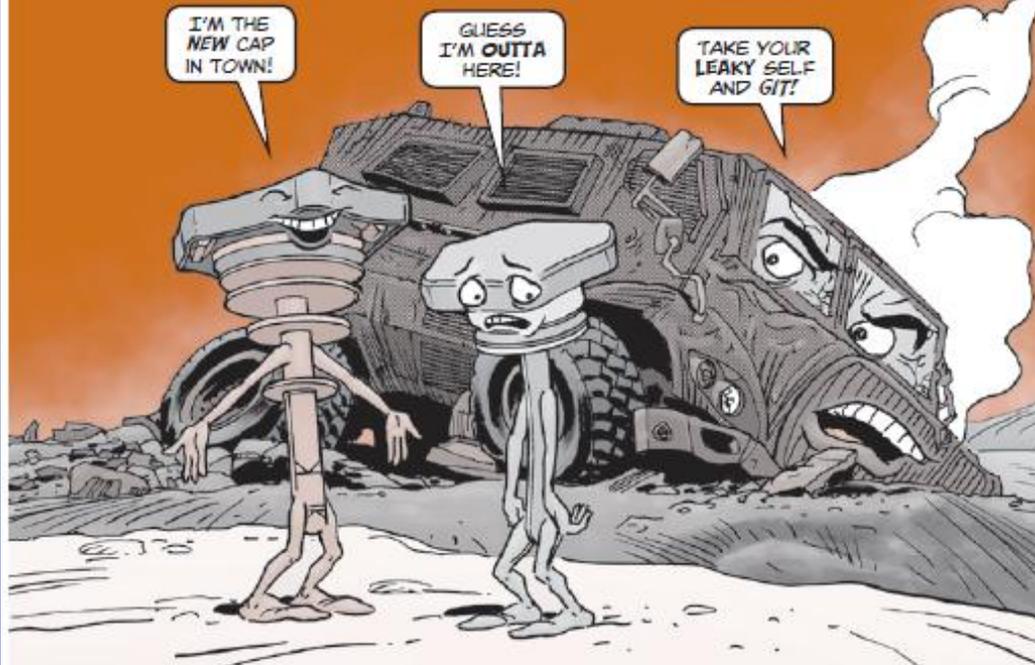
POWER STEERING CAP'S A REAL MISHAP!

A loss of power steering fluid will cause the MaxxPro to steer hard or erratic during operation—or not at all!

The culprit is usually the vehicle's original power steering reservoir cap, NSN 2590-01-556-5316. It's a known leaker.

To stop fluid loss, replace the old cap with a new style cap. The new cap, NSN 6680-20-006-4251, has three baffles on its dipstick that keep fluid from seeping past the cap.

So eyeball the cap you have on your MaxxPro. If it's the old-style cap, replace it now.
