# QUICK CHECK FOR THE QUICK-DISCONNECT

There's been a rash of blown steering gear seals on the M1117 armored security vehicle (ASV) and M1200 Armored Knight fire support vehicle (FSV) lately.

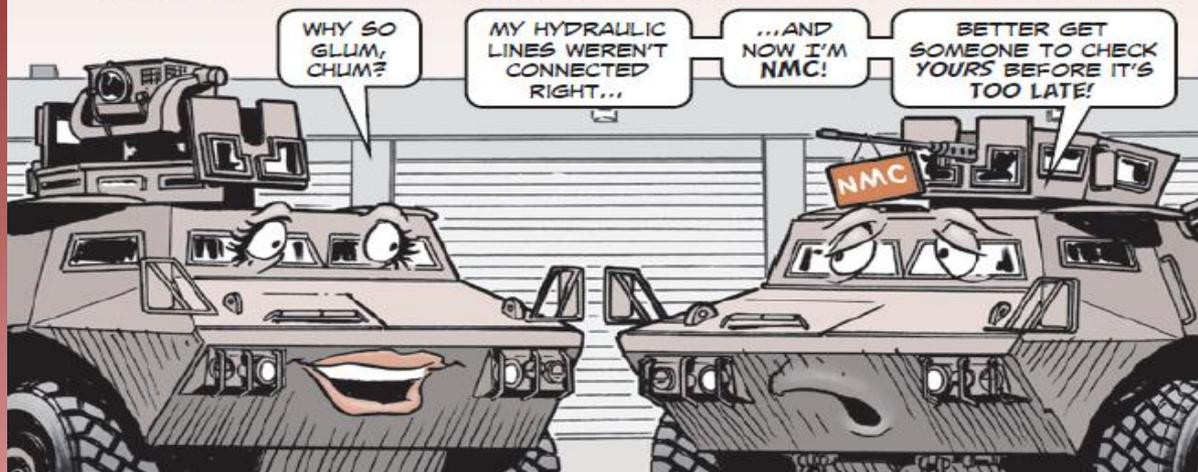
Some mechanics haven't been careful enough when connecting the hydraulic system's supply and return lines. If the quick-disconnect isn't fully seated, the hydraulic system will over-pressurize, causing a blown seal on the steering gearbox. A blown seal makes the vehicle NMC!

When connecting the supply and return line quick-disconnects, make sure there's no more than a  $\frac{1}{8}$ -in gap between the shoulder of the male end and the top of the female end. A wider gap means the hose line isn't properly connected.

This problem is happening more and more often after annual services. So before you finish with services, eyeball the hydraulic line connection for the correct gap.
