COVER STOPS CABLE FAILURE

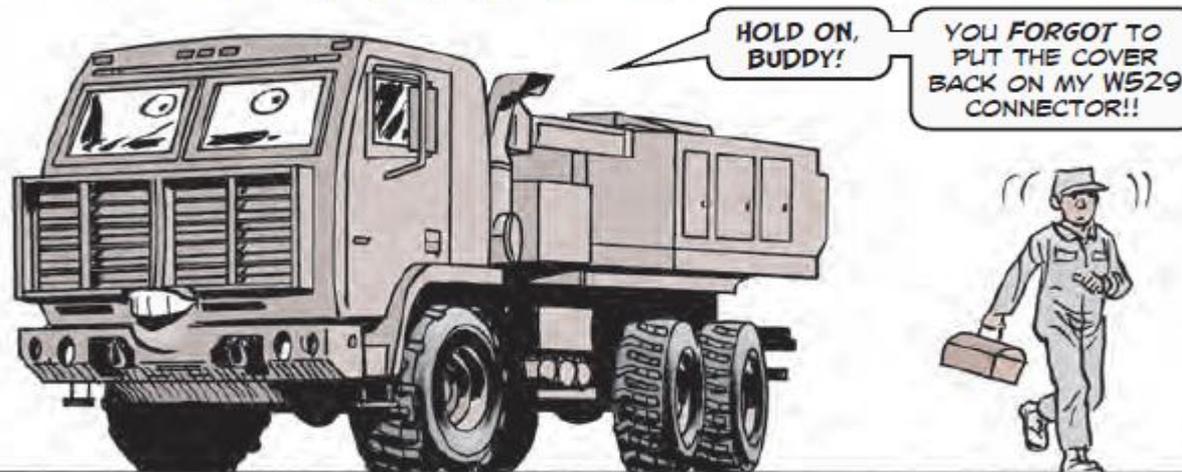
Since 2007, the HIMARS' W529 cable assembly has failed 38 times. Half those failures were in 2011. The W529 is failing because crews fail to install its cover.

The W529 cable connector has a cover that should always be installed except when the SNVT test is being run or when the W19P2 cable is stowed. When the test is over, the cover needs to be put right back on and left there.

Without the cover, the connector has no protection against moisture or backblast from rockets firing. Corrosion eats away at the connector's pins and soon there's no electrical connection.

So do your HIMARS a favor and use the W529 cover. And check for the cover during your weekly PMCS. Order a new one through your Lockheed Martin rep with P/N MS27502B17N if it's missing.

Keep cover on **except** when doing SNVT testing or when W19P2 cable is stowed
